Control of Wind Erosion

December 1971

State of California
Department of Public Works
Division of Highways
Materials and Research Department

CONTROL
OF
WIND EROSION

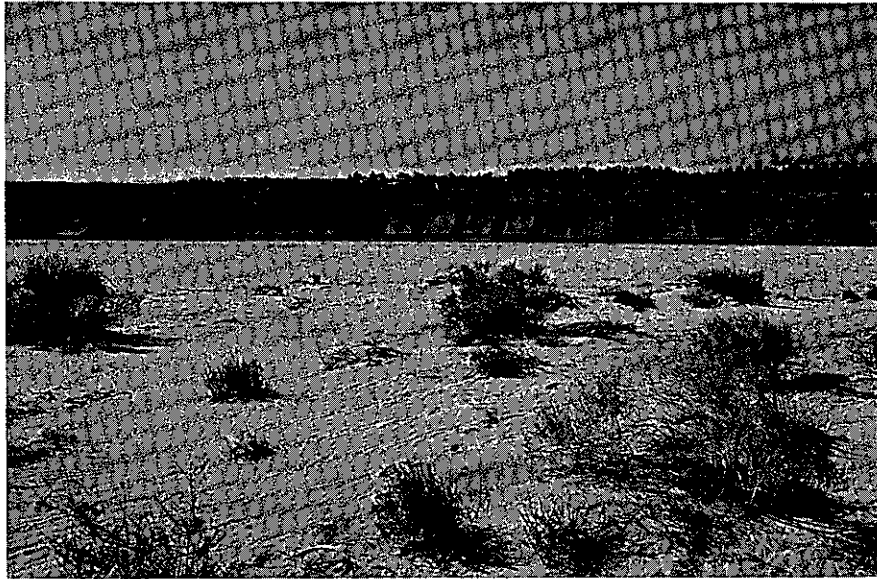
Plate 1 - Overall view of test area on March 5, 1971. Seven test plots are located beyond the plot at the edge of the photograph.

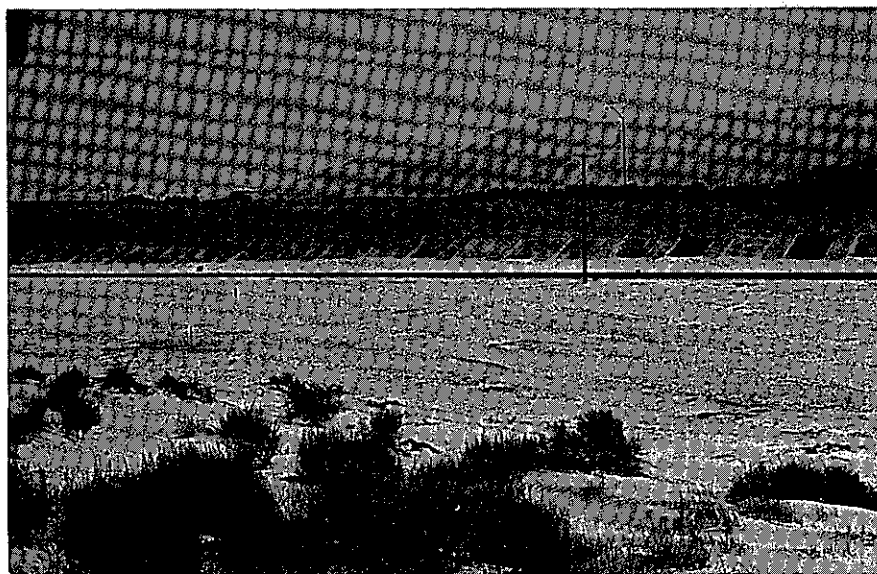
Test plots 13 through 30 on August 30, 1971.

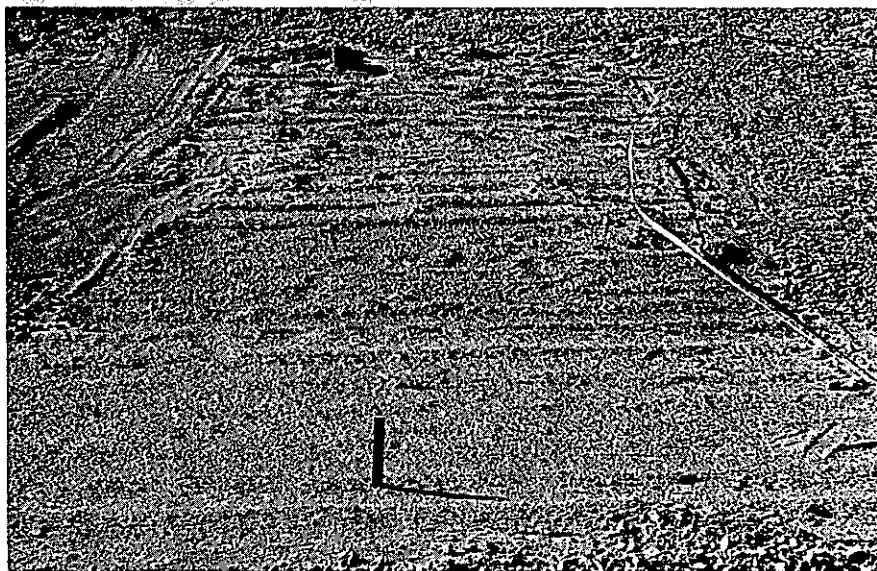
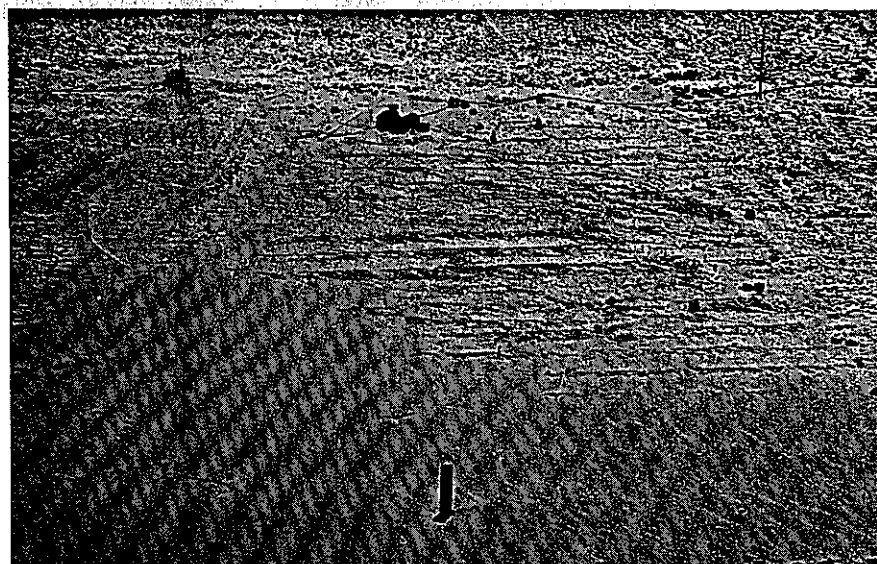
Plate 27 - Erode-X

Erode-X is a white viscous concentrate of an unknown plastic material which must be diluted with water before application. It has no strong odor and is easy to use and clean up. It dries to a colorless hard thin surface. Plates 27 and 28 show the test plots treated with Erode-X.

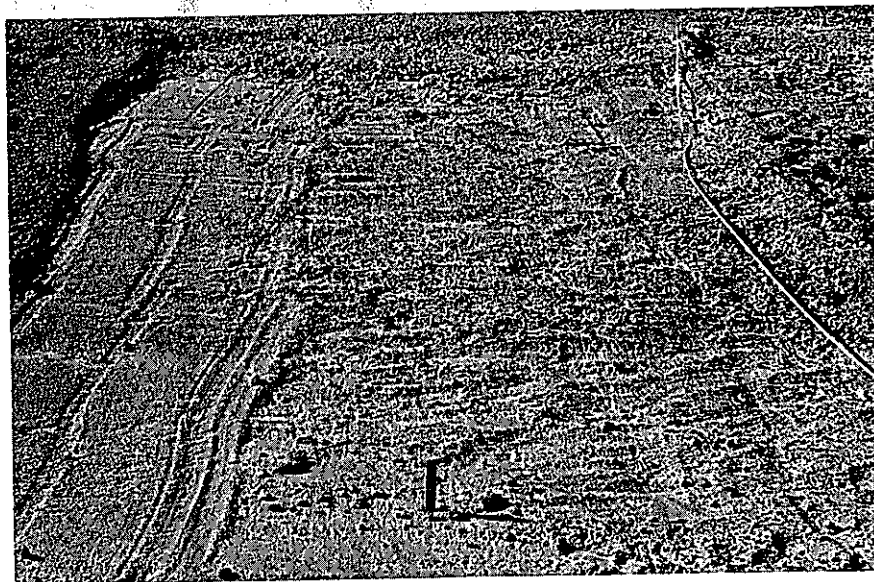
Plate 31 - Orzan

Orzan is a dark brown extremely viscous solution of chemicals and liquin sulfonate. It has a strong odor and is very easy to use and clean up. The dark color of this material did cause a discoloration of the test plot. Orzan exhibited remarkable penetration which resulted in a hard surface approximately three inches thick. This material also developed deep shrinkage cracks which did not interfere with performance but which are unsightly. Plates 30 and 31 show the test plots treated with Orzan.

The performance of Orzan was judged satisfactory because the surface was not damaged at all. The color and shrinkage cracks are definite disadvantages that should not be forgotten.
